## **Worn knife seatings in the best of hands**

Laser cladding is the "knight in shining armour" for a sawmill

# Verschlissene Messersitze in besten Händen

## Laserauftragschweißen als Rettung in der Not für ein Sägewerk

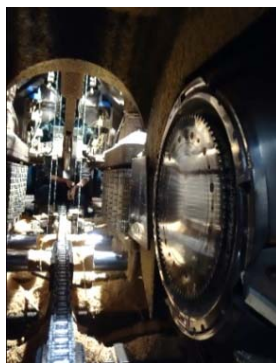
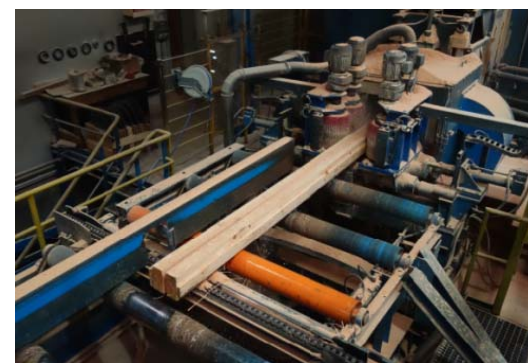
Bild 22-23: Die insgesamt vier Kreismesseraufnahmen sind extremen Bedingungen ausgesetzt: Hier werden Rindenreste und Unebenheiten entfernt und die Rundungen zu geraden Flächen geschnitten.

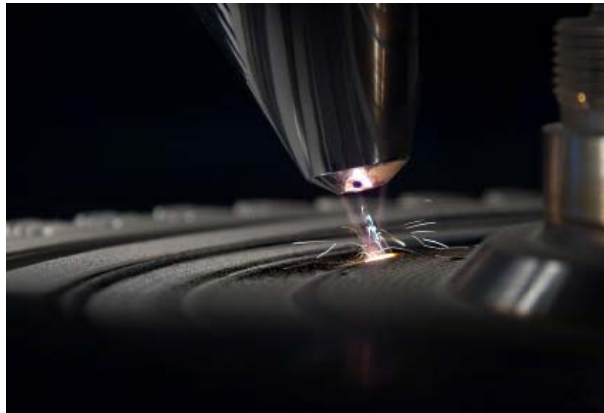
Bild 32-33: Für den 6 kW Diodenlaser entwickelte Pallas ein modulares Programm, das es dem Oberflächenspezialist erlaubte, an die Verschleißstruktur angepasst zu pulsen.

One particular challenge that Pallas faced was that the tool holders had no basis. In addition, the tool clampings were not only worn to different degrees. The hardness in the worn areas also had an extremely inhomogeneous distribution, with differences in hardness of up to 40 HRC. For this reason, Pallas decided to experiment on all four tool-holding fixtures with different working materials that had differing corrosion resistance and material hardness grades ranging from 50 to 63 HRC. However, the heterogeneous surface condition of the worn tool-holding fixtures did not permit any continuous coating with high-speed steels, which meant that more manual processing would be needed. Rodion Honisch developed a modular programme for the 6-kW diode laser to be used for the task, and this allowed him to adapt the laser pulsing to the specific configuration of the worn area. In this way, he could choose where to begin with the reconstruction: on the flanks, or on the lower edge. In laser pulsing, very short controlled bursts – the laser only flashes for just 200 milliseconds – apply the energy selectively to the material in order to repair complex geometries point by point. Thanks to the near-net-contour quality of the process, the coated tool-holding fixtures required only minimal post-processing, which was done with a Dremel. All in all, the repair of each tool clamping took at least eight hours.
